# Davis TruTrac™ Bar Installation Instructions FordV-10

## *F-53 Chassis WITH V-10 engines 1999-200x*

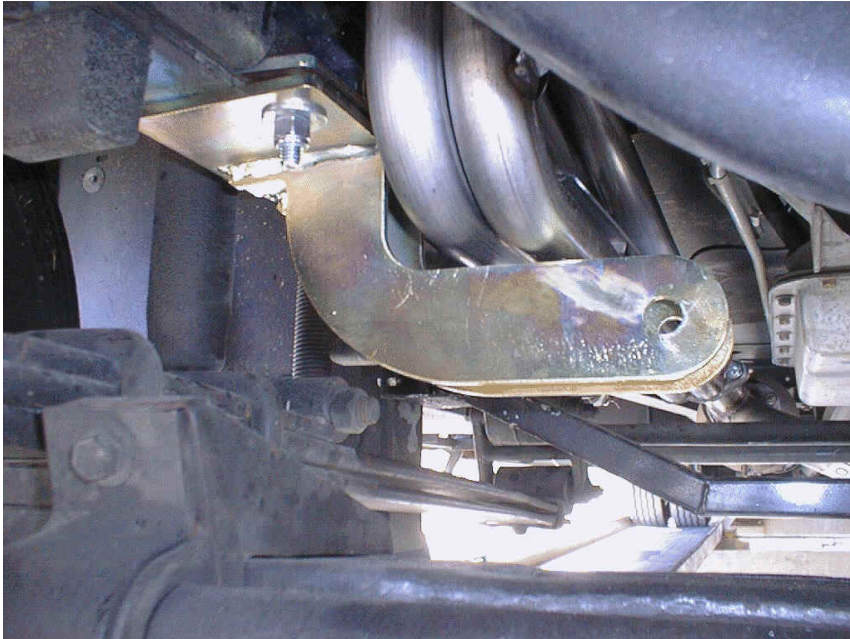
Figure 1 [Photo Shown with Banks Header]

On the passenger side of the vehicle locate the inside frame rail just forward of the shock absorber (See Figure 1 below). Find the 1" hole in the frame. There is a corresponding 1" plug on the TruTrac™ Bar passenger side bracket. Install the passenger side bracket in the frame with the long span pointed downward and toward the center of the coach and the "L" shaped backing plate on the opposite side of the frame rail. Install the three 1/2 x 2" bolts and washers and torque the nuts to 80-90 ft pounds.

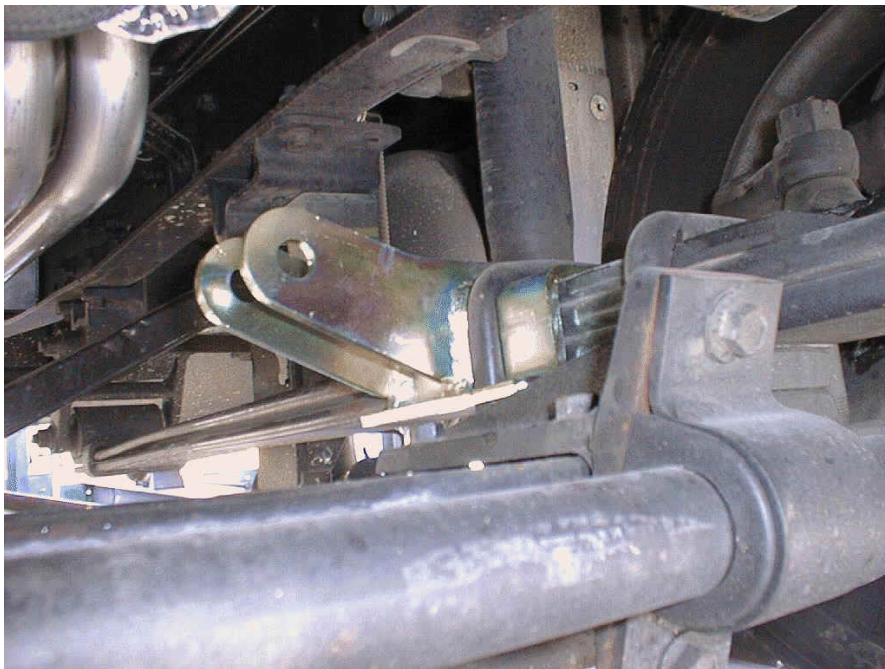
Remove the driver side front axle rear U-bolt (see Figure 2 below). Only the rear U-bolt needs to be removed. Set the TruTrac™ Bar axle bracket on top of the spring with the ear and the holes toward the center of the vehicle and pointing up. Re-install the factory axle U-bolt previously removed. Occasionally the U-bolt may spread when removed. It may be necessary to adjust the U-bolt in a vice to re-install it. Re-use the factory nuts and washers and torque to 220-230 ft. pounds.

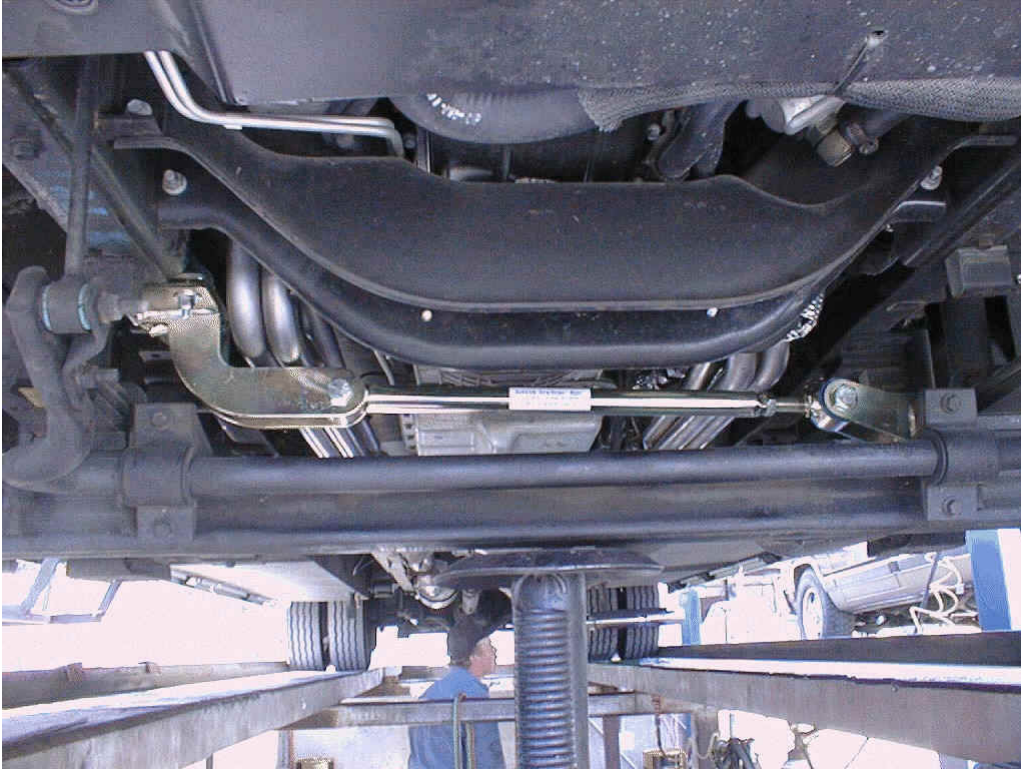
Figure 3

Re-check installation [see figure 3 below]. If vehicle is equipped with a Safe-T-Plus steering stabilizer, re-adjustment of the Safe-T-Plus may be necessary. Test drive the vehicle and re-inspect installation. Re-check all nuts and bolts for tightness.

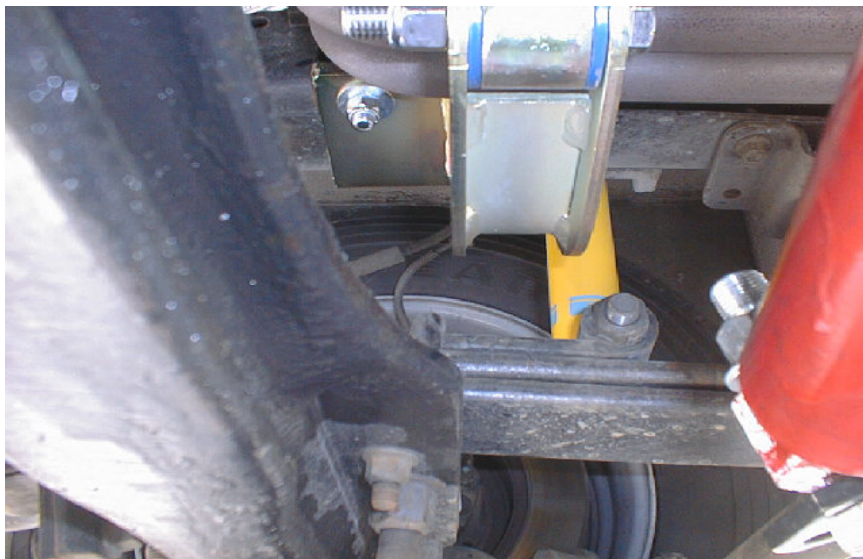
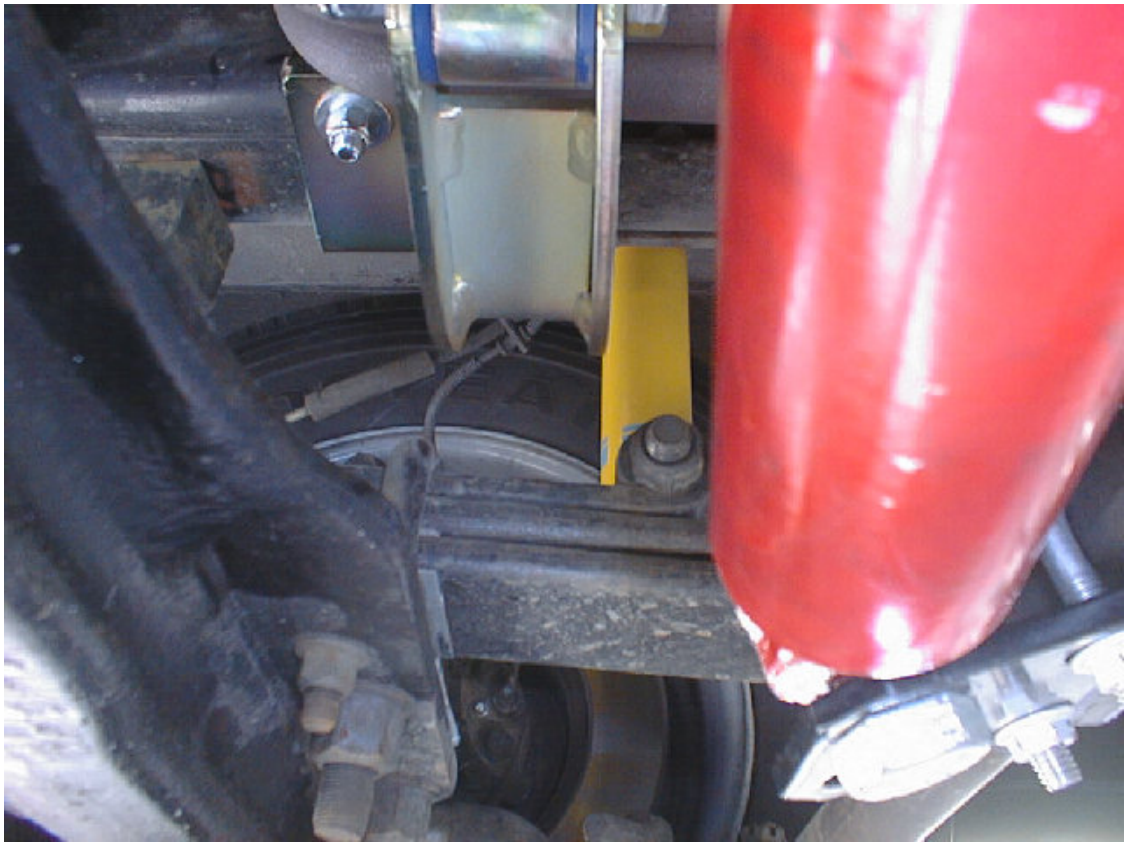
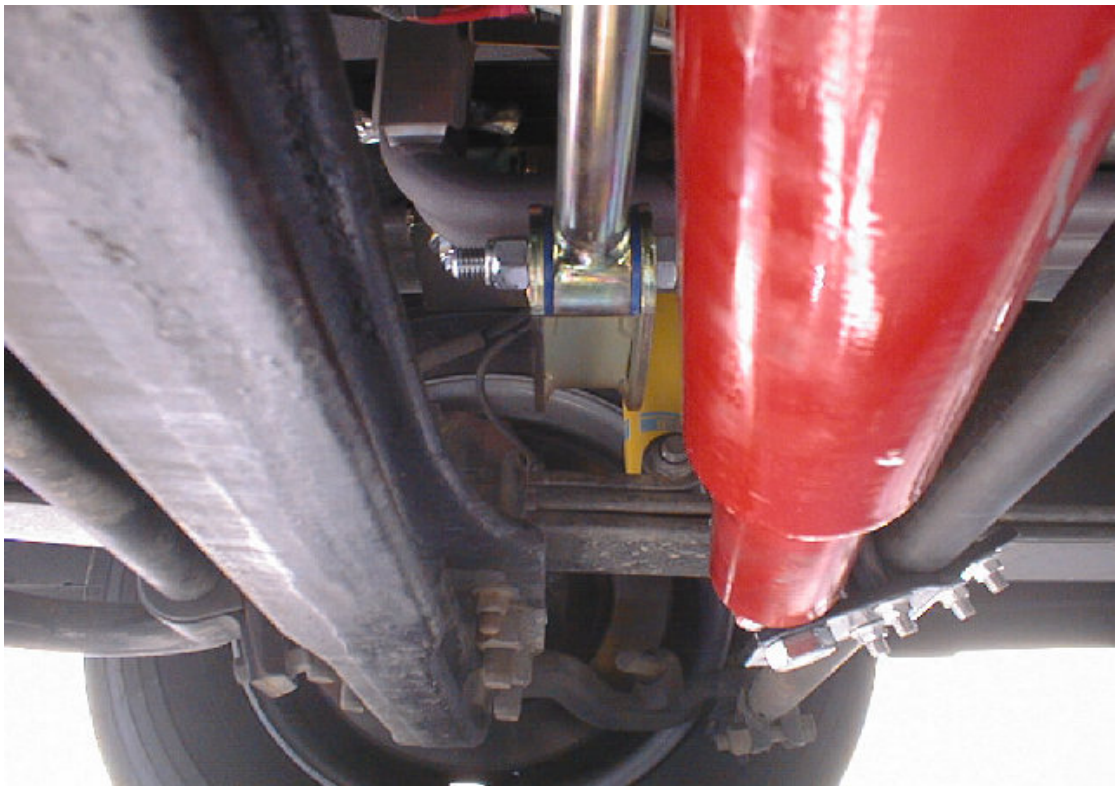
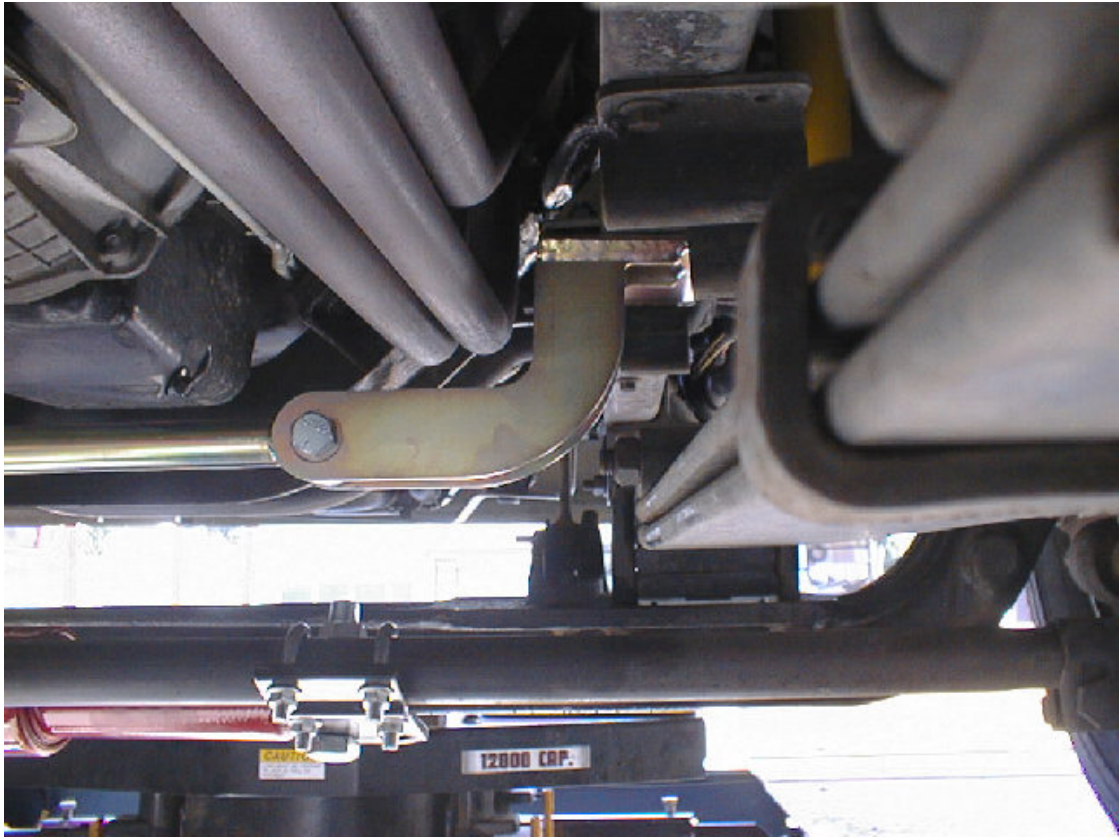
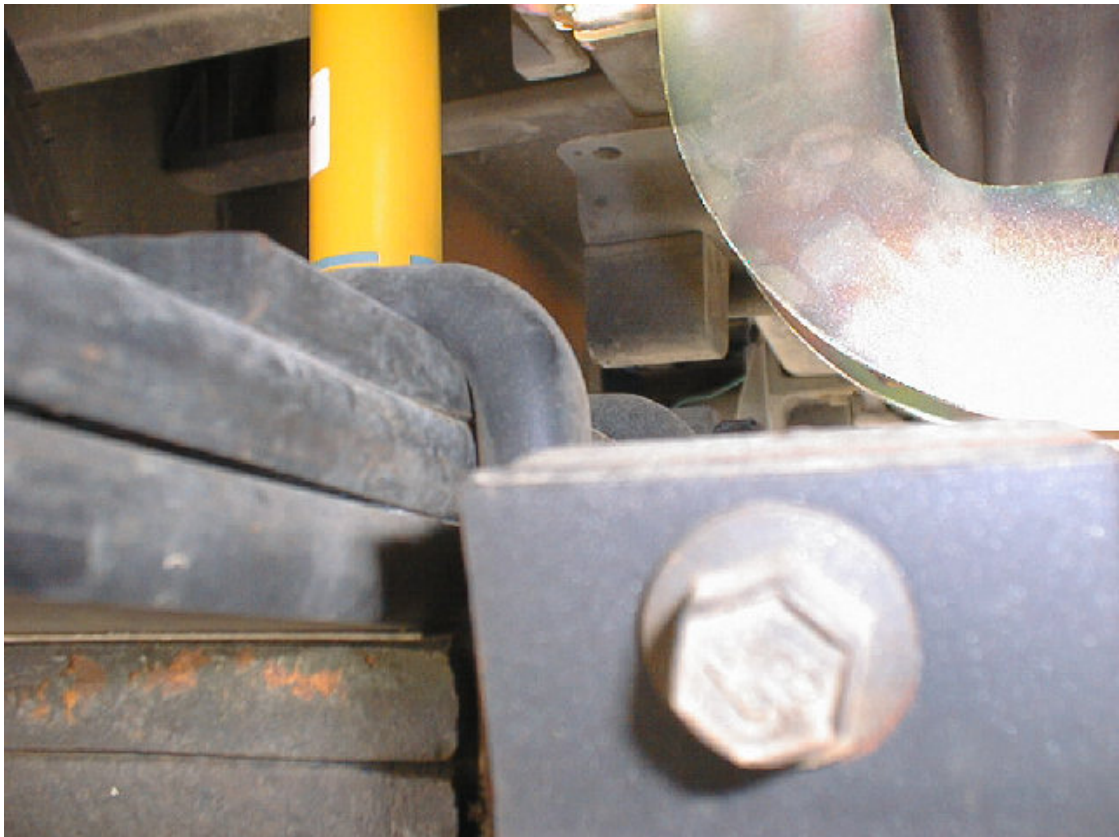
We've added 5 Special Clearance Photos (below)

These photos show the expected clearances of the frame bracket. It has come to our attention that a few [3 reports in 4 months] vehicles have restricted clearances. If you are having difficulty please call Eric's RV Performance Center at 800-488-3697 and provide us with complete vehicle information. Thank you.
