# Davis TruTrac<sup>™</sup> Bar Installation Instructions

# F-53 Chassis with 460 cu in engines

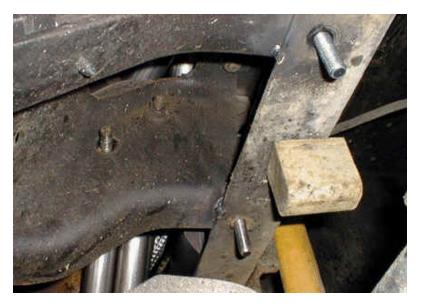
Figure 1

Remove 2 factory bolts in the driver's side frame member above the front leaf spring. One bolt is located on each side of the rubber bumper stop. [see figure 1 below] Discard the factory bolts (do not discard the factory nuts and washers) and install the 2 new 12x50x3/4" bolts supplied. Remove the corresponding factory motor mount nut and washer - do not remove the factory bolt.

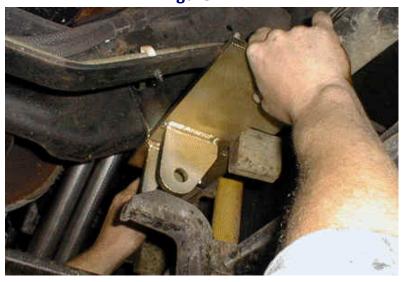
Figure 2

Install upper TruTrac<sup>™</sup> Bar bracket [see figure 2 below] on the motor mount bolt and re-install factory nut and washer. Hold the TruTrac<sup>™</sup> Bar bracket in place and re-install factory nuts and washers in frame. Torque all nuts and bolts to 80-90 ft. pounds.

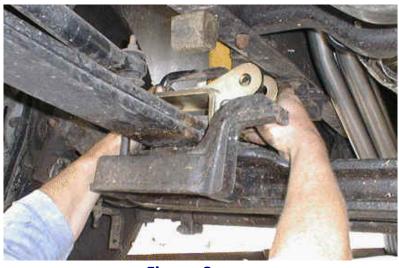
Figure 3

Remove passenger side front spring axle U-bolt. Only the front U-bolt needs to be removed. Set the passenger side TruTrac<sup>™</sup> Bar bracket on top of the spring with ear and hole toward the center of the vehicle and pointing up [see figure 3 below]. Install new U-bolt supplied and torque to 220-300 ft. pounds.

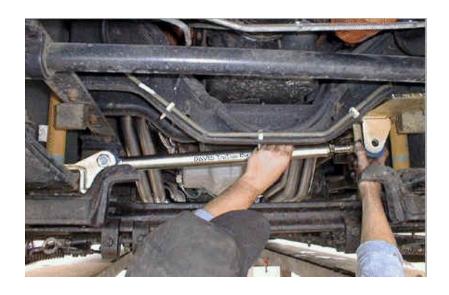
Figure 4

Insert TruTrac<sup>™</sup> Bar bolt supplied through axle bracket and solid end of TruTrac<sup>™</sup> Bar. Adjust the TruTrac<sup>™</sup> Bar alignment [see figure 4 below] until the second TruTrac<sup>™</sup> Bar bolt slips easily into frame bracket and adjustable end of TruTrac<sup>™</sup> bar. Note: bolts must be installed from the front with nuts on the rear to avoid clearance problems. Install lock nuts supplied and tighten nuts and bolts being careful to avoid compressing brackets and bushings. Tighten adjustment lock nut. If vehicle is equipped with front air bags some modification of the air bag brackets may be necessary.

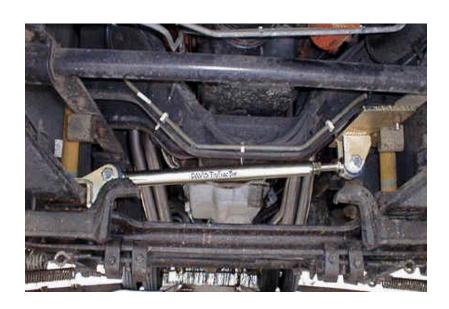
Figure 5

Re-check the installation [see figure 5 below]. If vehicle is equipped with a Safe-T-Plus steering stabilizer, re-adjustment of the Safe-T-Plus may be necessary. Test-drive the vehicle and re-inspect installation. Re-check all nuts and bolts for tightness.
